# APPLICATION STORY

## FLIR THERMAL IMAGING CAMERAS REVEAL HIDDEN DEFECTS IN FLOOR HEATING SYSTEMS

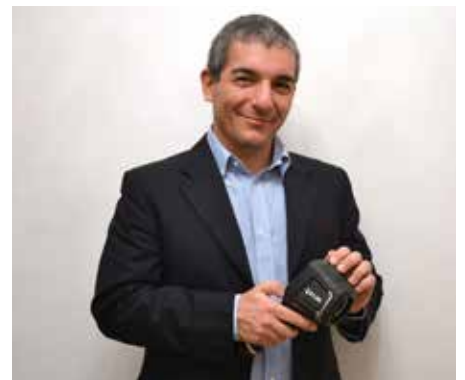
*The FLIR E8 has a 320x240 detector, a focus-free lens and simple button navigation to on-screen settings, imaging modes, measurement tools, and saved JPEGs.*

The FLIR E8 has a 320x240 detector, a focus-free lens and simple button navigation to on-screen settings, imaging modes, measurement tools, and saved JPEGs. The camera is amazingly easy to operate, even with just the press of a single gloved thumb. The E8 also features FLIR's proprietary MSX® Thermal Image Enhancement functionality, which adds key details from the onboard visible light camera to the entire infrared image in real time.

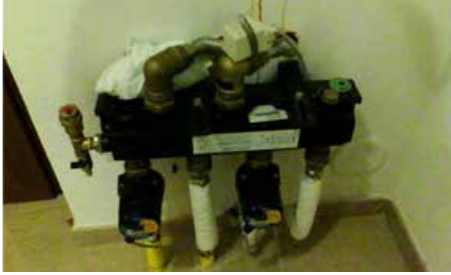
Figure 1a: Visual image of a manifold.

Figures 1a/1b/1c show a manifold that feeds a radiant heating system with circulator pumps, one for each manifold section. Points Sp1 and Sp2 actually are almost at the same temperature but having set the same emissivity value leads to misleading conclusions. In reality, electrical tape has been applied to Sp1, which has an emissivity that is very close to the value set in the instrument. Therefore, the fluid flow is actually at 44°C and not at 30.5 °C.

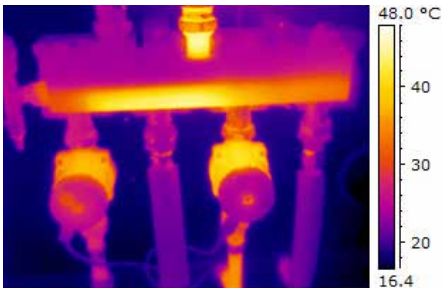
Figure 1b: Thermal image of a manifold with an inactive left pump.

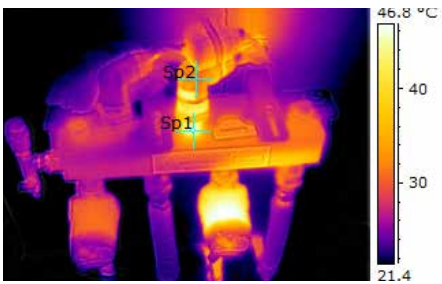
Figure 1c: Thermal image of a manifold with the left pump actively running.

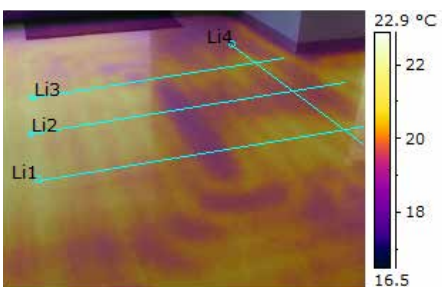
Figure 2: Radiant circuit during start-up

Figure 2 shows a radiant circuit during start-up, digitally fusing the thermal and the visual images. Profile analysis has been performed on the pseudo orthogonal lines Li1, Li2 and Li3, running over the pipes. On the right, line Li2 shows a colder, uneven area which should be investigated further, since it may mean that there are changes in the thickness of the screed or in the adhesive used for finishing. Line Li4, in green, highlights this thermal variation that should not occur along just a few decimeters of pipe.

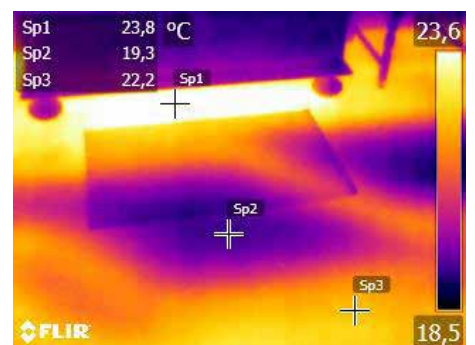
Figure 3: The presence of a radiant system behind furniture or other obstacles basically increases the inertia of the system both during startup and shutdown. Sp1 Temperature 23.8 °C, Sp2 Temperature 19.3 °C, Sp3 Temperature 22.2 °C

Be it as it may, the presence of a radiant system behind furniture or other obstacles basically increases the inertia of the system both during startup and shutdown and does not really help control the room's temperature. Actually, it creates a barrier to heat flow towards the areas occupied by the obstacles, a barrier which obviously has a cost in terms of energy. This is demonstrated in Figure 3.
